Ka 8 and Ka 8 B/C **"Rhönsegler"**

Operating Instructions

Operating Instructions
for the Sailplane
Schleicher K8 and K8 B

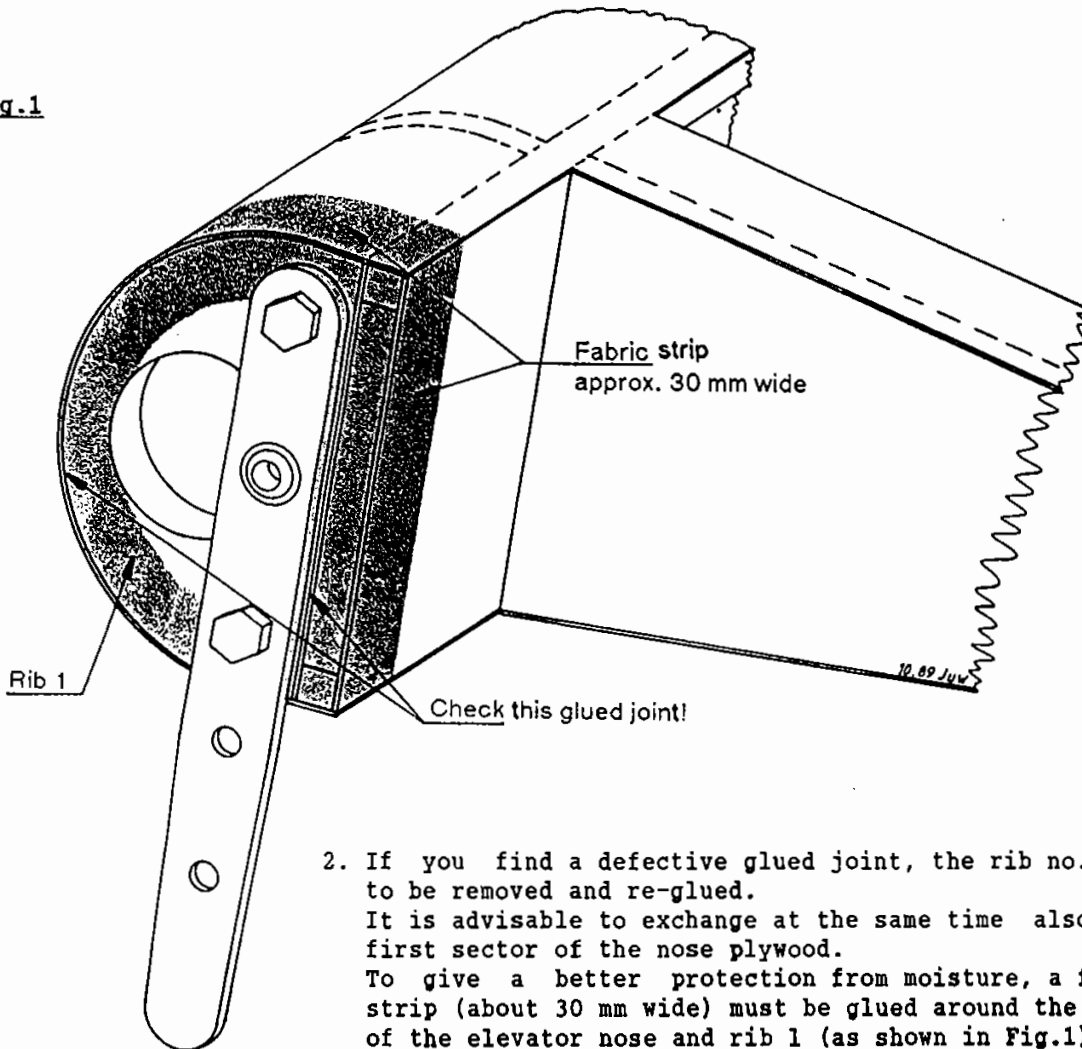
Fig.1

A glider of the model K7 failed to gain normal flight attitude immediately after tow rope release on winch launch. With the stick full back only the left elevator could be actuated in the correct direction; the right elevator deflected downwards. The reason for this was a loose glue bond at the elevator rib 1 at which the elevator fitting is attached. Similar incidents lead already before to the issue of the LTA 72-7 dated Feb.9,1972.

Loose glue joints on rip 1 of the elevator

1. Remove elevator.
Check that the glued joint between rib 1 and the leading edge plywood and the elevator spar respectively is in good condition (see Fig.1). Before doing so check whether the LTA 72-7 of Feb.9, 1972 was already previously accomplished (this is not applicable to K9, K11 and ASK 18); if yes then the fabric strip first carefully has to be detached in order to be able to check the glued joint.

2. If you find a defective glued joint, the rib no.1 has to be removed and re-glued.
It is advisable to exchange at the same time also the first sector of the nose plywood.
To give a better protection from moisture, a fabric strip (about 30 mm wide) must be glued around the edge of the elevator nose and rib 1 (as shown in Fig.1).
3. The above action under points 1. and 2. must be repeated every three years during the annual re-inspection. This copy of the Technical Note must be inserted in the Flight and Operations Manual of the respective glider as an annex and a corresponding entry must be made into the "Amendments to the Manual".

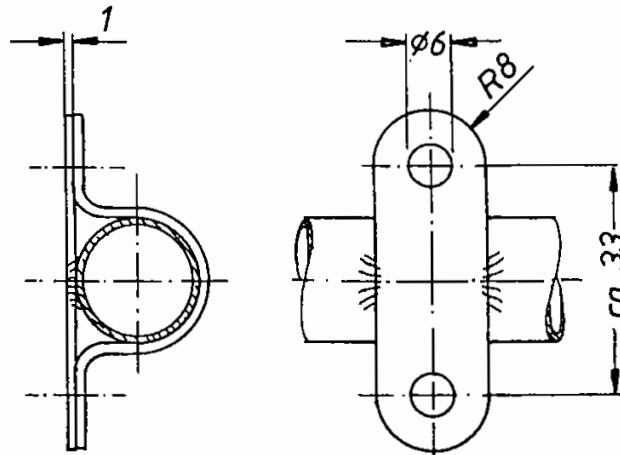
Fig. A2

Reinforcing the attachment collars for pedal boards at the pedal assembly. Material: 1.7734.4
Welding procedure WIG to spec DIN 1912, welding wire material: 1.7734.2

- ad A2) Checking the rudder pedals:
With the rudder neutral the pedals left and right must be evenly adjusted. Check the pedal board angle versus the pedal (dimensions see drawing L-216.42-U01). The angle must meet the specified dimension.
Engage the pedal adjustment into its foremost position and check full deflection of the rudder.
Where pedals or attachment collars are bent, these can be either repaired or replaced by new ones.
In order to impede the bending of the pedal boards it is optionally recommended to weld an additional butt strap onto the attachment collar (see Fig.A2).

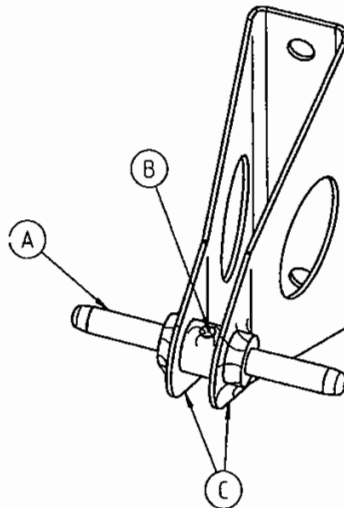
Fig. 1

Grund:
Reason: Bei einem Segelflugzeug wurde festgestellt, daß die Achse (A) des Höhenruderlagers lose war. (siehe Fig. 1)

Die Achse ist in einer Buchse geführt. Durch ein Loch (B) in dieser Buchse ist sie festgeschweißt. Diese Verbindung hat nicht mehr bestanden.

On one glider it was found, that the axis (A) of the central support of the elevator was loose. (see fig. 1). This axis is supported in a bushing. Through a hole (B) in this bushing, the axis is fastened by a weld. This welded connection did not exist any more.

Das Höhenruder demontieren. Prüfen, ob die Lagerachse (A) fest sitzt. Dabei sind zusätzlich auch die Bleche des Lagerbocks rund um die Schweißnähte (C) auf Risse zu prüfen (mindestens mit einer Lupe 10facher Vergrößerung). Gegebenenfalls ist der Lagerbock zu ersetzen. Diese TM ist als Anhang in das Flug- und Betriebshandbuch einzufügen und im Berichtsstand einzutragen.

At that occasion, the sheet metal of the support is to be checked for cracks around the welds (C) (at least with a 10x magnification loupe).

When indicated, the support must be replaced.
